ENGINEERING-SCIENCE, INC.

May 18, 1993

Subject: F33615 - 90 - D - 4014, Order 04,
O&M Effort for the Bioventing System at the 7th Street BX Service Station
(May 1992 through 1st Week in May 1993), Eglin, AFB

**O&M EFFORT FOR THE BIOVENTING SYSTEM AT THE 7TH STREET BX
SERVICE STATION (MAY 1992 THROUGH 1ST WEEK IN MAY 1993),
EGLIN, AFB**

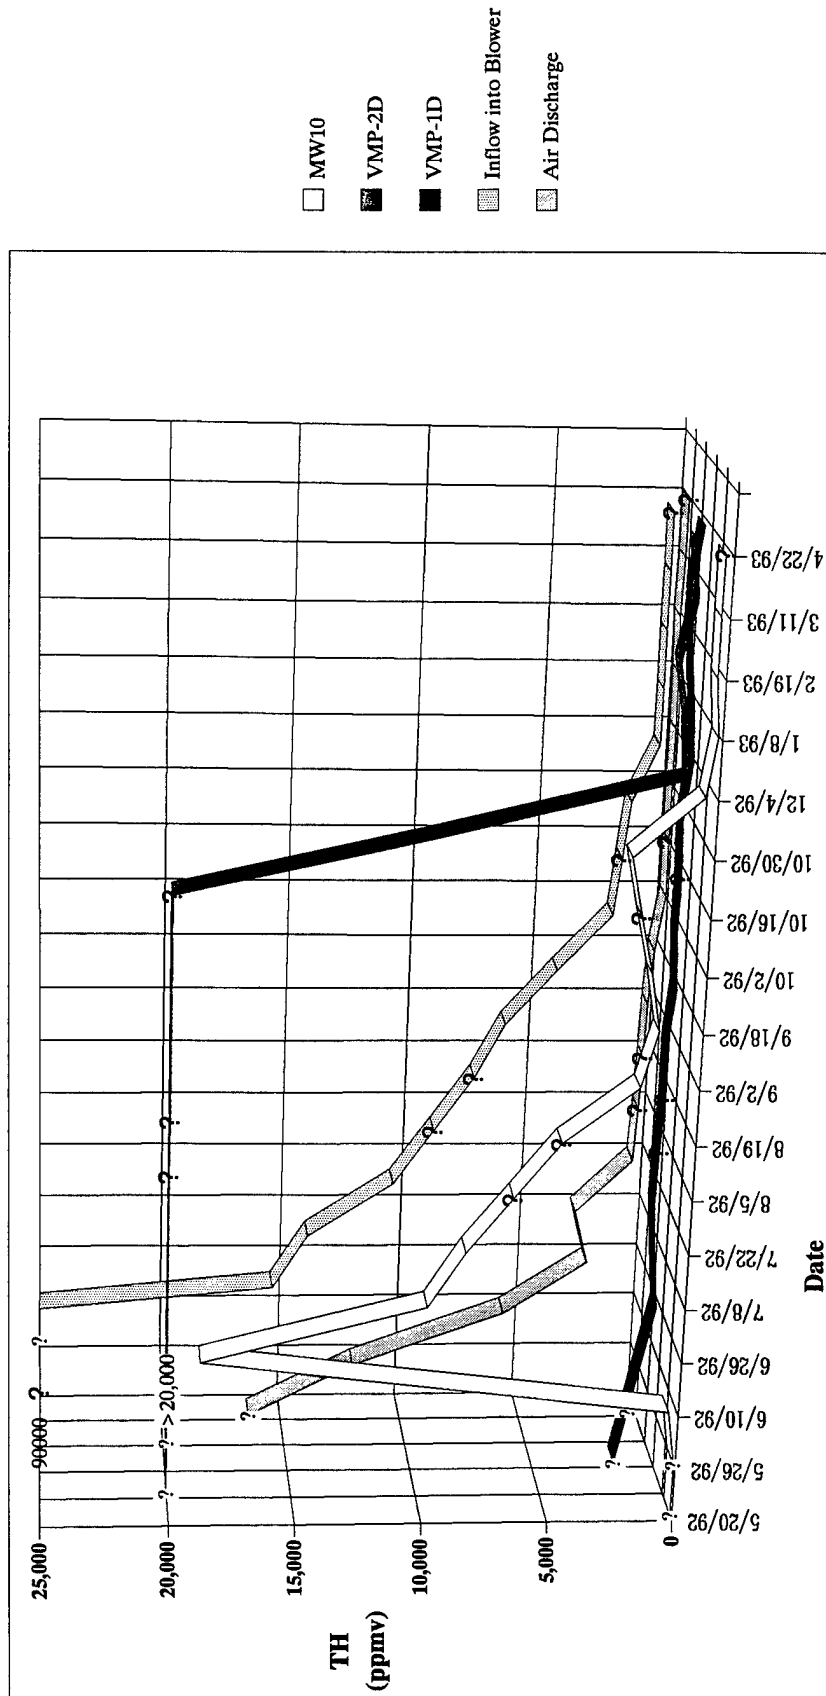
Figure 1

Results of biweekly/monthly concentrations of oxygen, carbon dioxide and Total Hydrocarbons throughout the bioventing system are presented in Table 2 and depicted in the attached charts (Figures 1 through 3). These results continued to indicate increased biological activity in the subsurface and suggest potential increase in aerobic bacterial population. Results indicate oxygen supply to the subsurface has been adequately sustained except for a recent measurement that showed a pronounced decrease in oxygen concentration and slight increase in Carbon dioxide concentration at monitoring location VMP-1D. This monitoring point will be observed closely to determine if increase in bio-uptake of oxygen is the reason for the decline in oxygen level. Available data indicate a rapid decline in total hydrocarbon concentration over the past five months (December through April). Volatilization and to a greater extent biodegradation are believed to be responsible for the total hydrocarbons removed. The system will be watched closely to observe changes that would likely occur as a result of increasing warm weather conditions.

TOTAL HYDROCARBON LEVELS DURING BIOVENTING AT 7TH STREET BX SERVICE STATION (5/20/92 - 4/22/93) EGLIN AFB

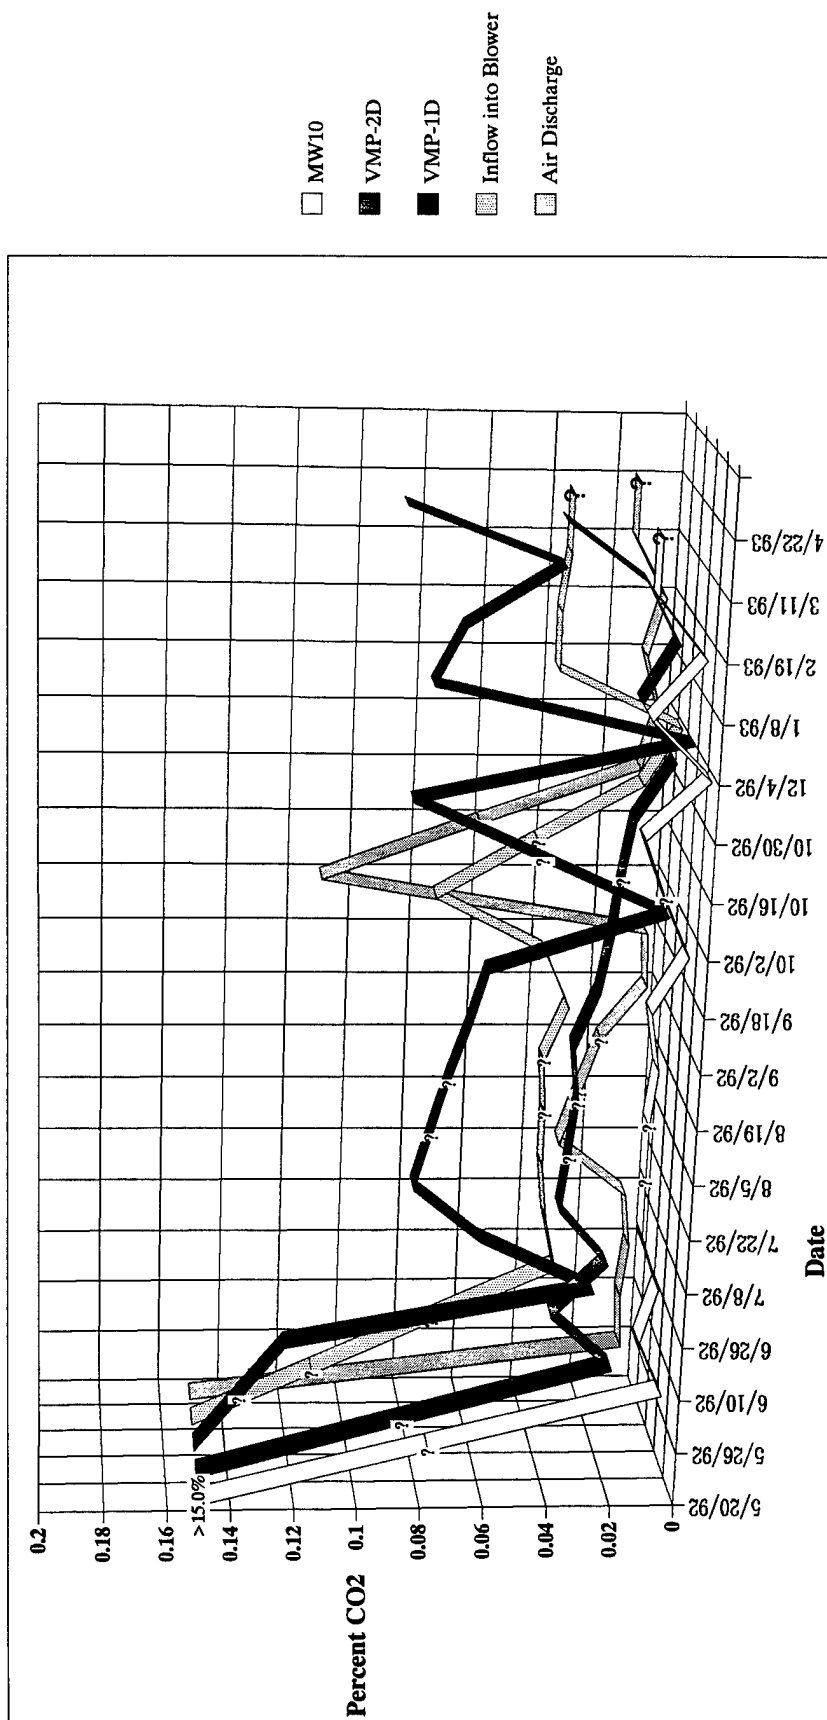
Figure -2

Off gas monitoring effort in February reflected a similar trend in attenuation of total hydrocarbons in the soil gas as in previous months. Other physical parameters measured in the field were consistent with previous data and indicated adjustment to the system components was not warranted. A fair amount of rainfall occurred during early to mid February but was not as much as in previous months (November through January). An in-situ respiration test was scheduled for the 2nd week in March. Data gathered during the month of February is included in Tables 1 and 2 and depicted in Figure 2.

**CARBON DIOXIDE LEVELS DURING BIOVENTING
AT 7TH STREET BX SERVICE STATION (5/20/92 - 4/22/93)
EGLIN AFB**

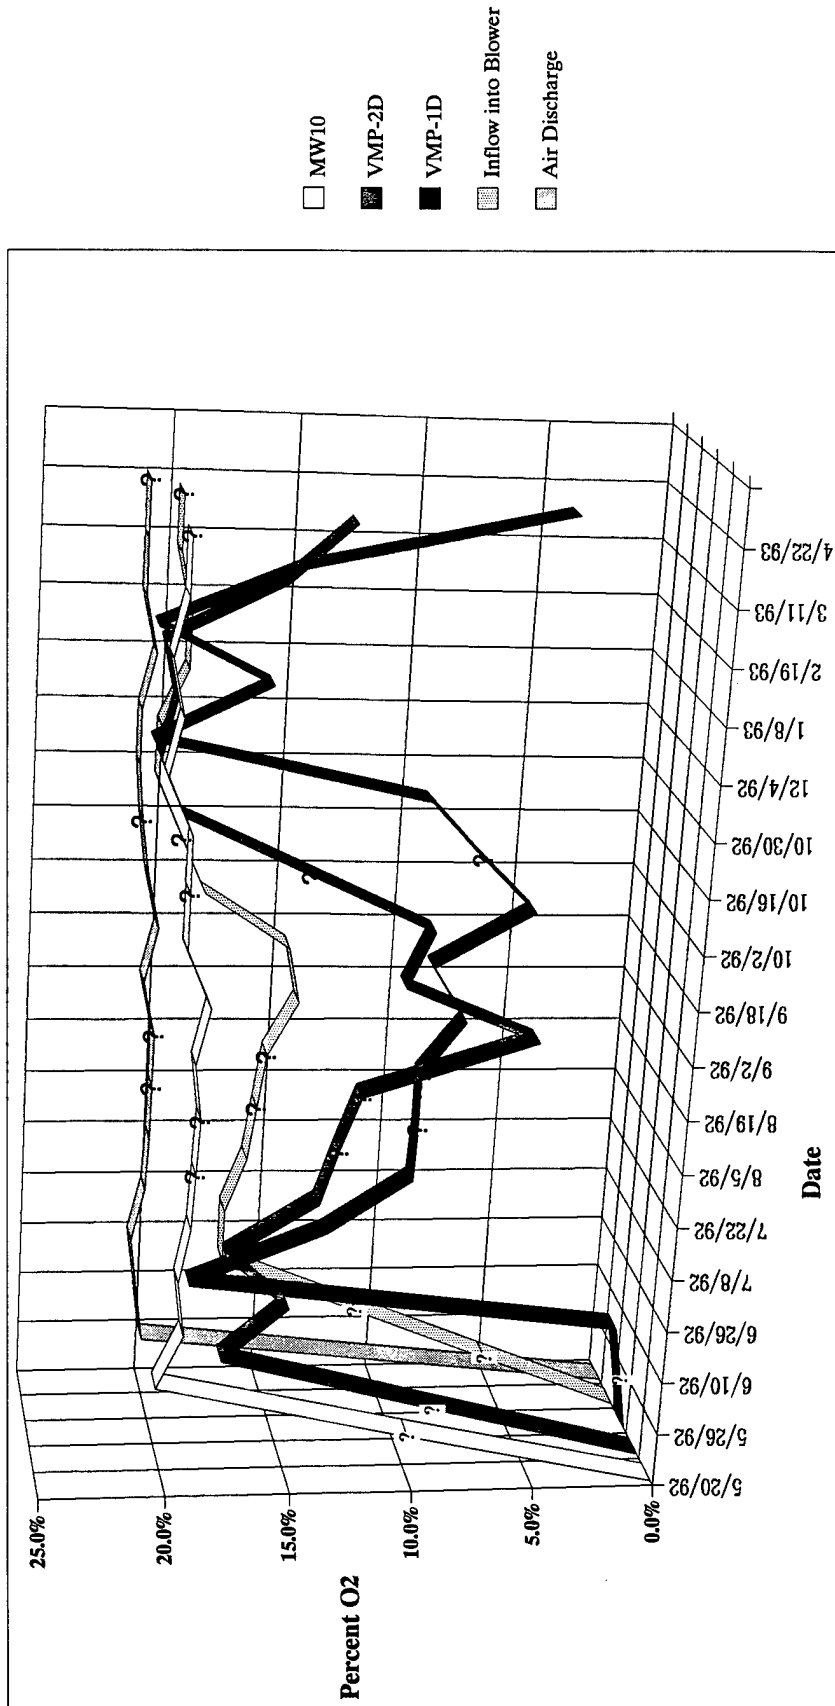
Figure 3

ES made two visits to the site during this period; one on April 7 and another on April 22. The lowest temperature readings since startup of system operation were recorded (Table 1). This was attributed to cold weather conditions experienced during this period. Oxygen levels dropped in both VMP-1D and VMP-2D and this was complimented by an increase in carbon dioxide levels. A continued decline in total hydrocarbons' level was evident at VMP-1D. A slight increase (>200 ppmv) in TH level was observed at VMP-2D. Other physical parameters remained virtually the same. The results of the soil gas samples taken from monitoring points at the site are presented in Figures 1 through 2. Water level measurements taken this period indicates a gradual decline in water table conditions (Table 3). It is anticipated that by the end of May the water table would have dropped low enough to allow performance of a respiration test.

**OXYGEN LEVELS DURING BIOVENTING
AT 7TH STREET BX SERVICE STATION (5/20/92-4/22/93)
EGLIN AFB**
